# Kenley Revival Community Archaeology Project 2018 Kenley Airfield London CR8

Archaeological Investigation Report

# Kenley Revival Community Archaeology Project 2018

Report on a community archaeological investigation

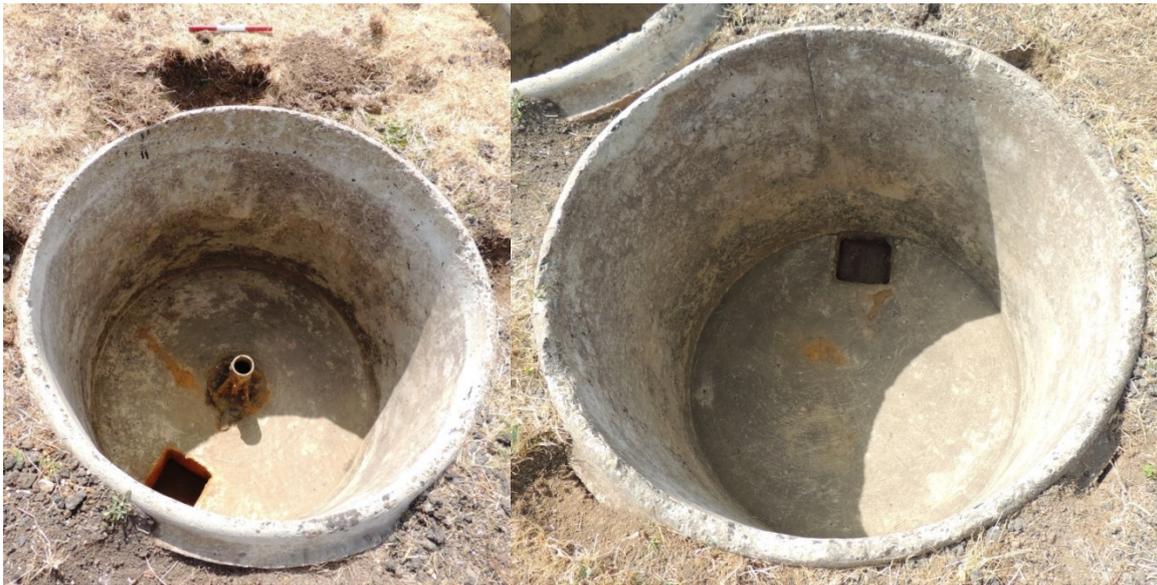
*Fig 5 Concrete rings with fitting and drains*

- 4.1.2 Both pipes had drains [110][117] made of extruded bricks (with holes in them) and solid bricks and a metal grate at the base of the one that was excavated [116], below [110]. The bricks may have been a temporary solution after a metal grate on top of the hole, in which they lay, failed. The centre of the southern pit [132] also had a metal fitting comprised of a circular plate fixed to the concrete floor, on which a 100mm-wide metal pipe had been fixed in an upright position, by strong metal flanges. This is thought likely to have been the fitting for an upright pedestal-mounted light machine gun (a “Stork Mounting” Lowry 2014, 41). The Stork mount held the gun at a safe distance from the operator, and it would have projected significantly beyond the sewer pipe<sup>2</sup>.

Scale is 300mm (left)

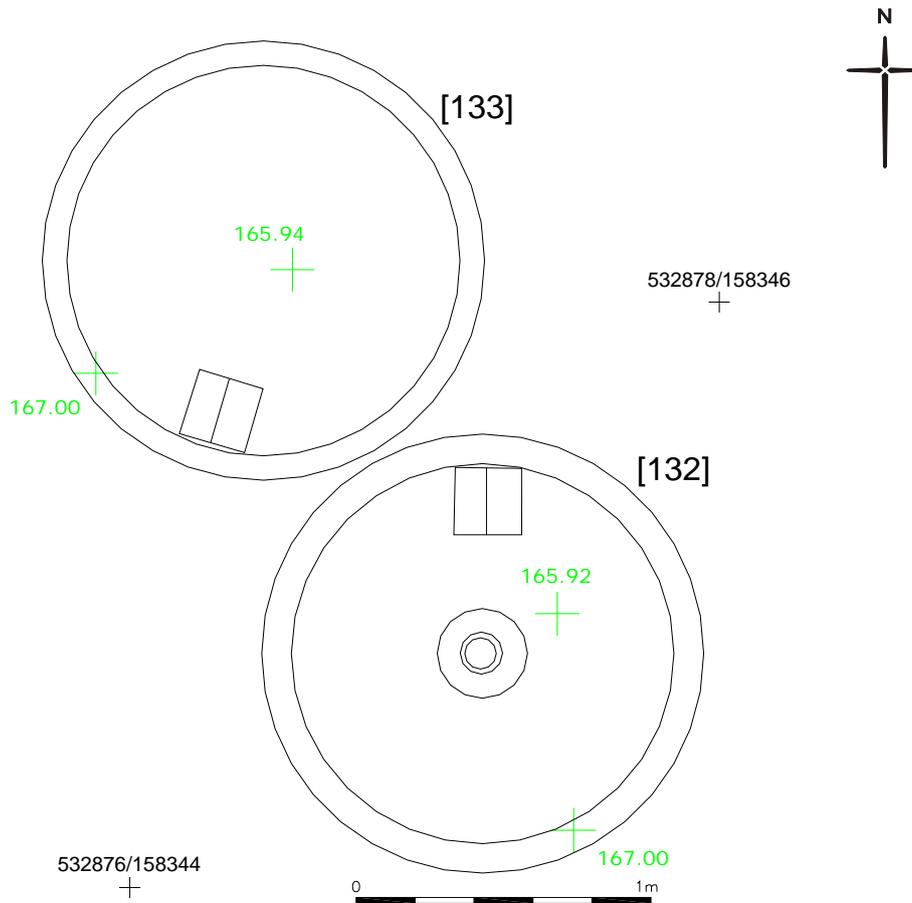
Fig 6 Plan of concrete rings

Levels in m OD next to crosses (eg. 167.00), OS NGR co-ordinates in Easting/Northing above crosses

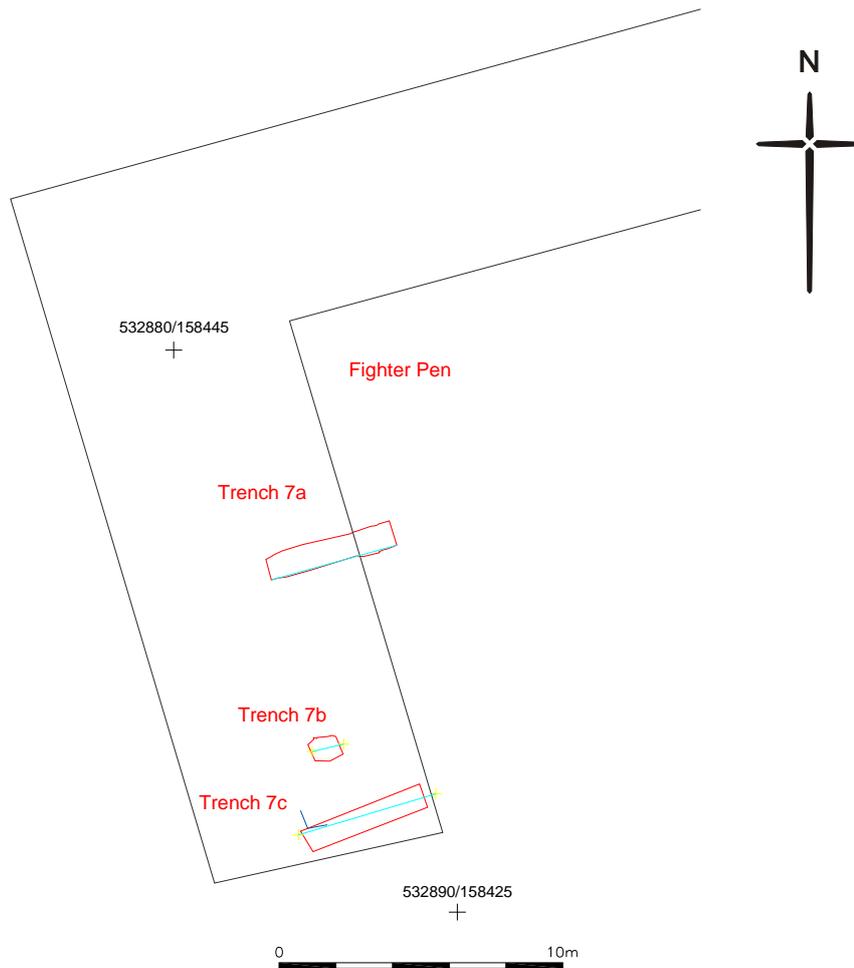
Fig 7 Trench 7 on the west arm of the fighter (blast-) pen

- 4.2.3 On the east (in-) side of the blast wall was a low concrete retaining wall [115]. Behind which were a series of dumped deposits, the lowest [113] contained frequent chalk fragments and flint nodules and was clearly the upcast natural subsoil (Clay with Flints formed by weathering of the underlying chalk bedrock). Above it sandy clay [108] was reworked from more surface deposits. It contained fragments of pottery, including one with the insignia of the NAAFI (Navy, Army and Air Force Institutes). Above that were two surface soil layers [111][112], which reworked [108]. These upper layers had formed against the side of a concrete ridge applied to the crest of the blast wall [114], 1.6m wide and 0.63m high it was formed of a centrally

moulded spine to 167.83m OD. Surrounding the inside of the blast pen was a sloping concrete skirt [124] to a gutter [125].

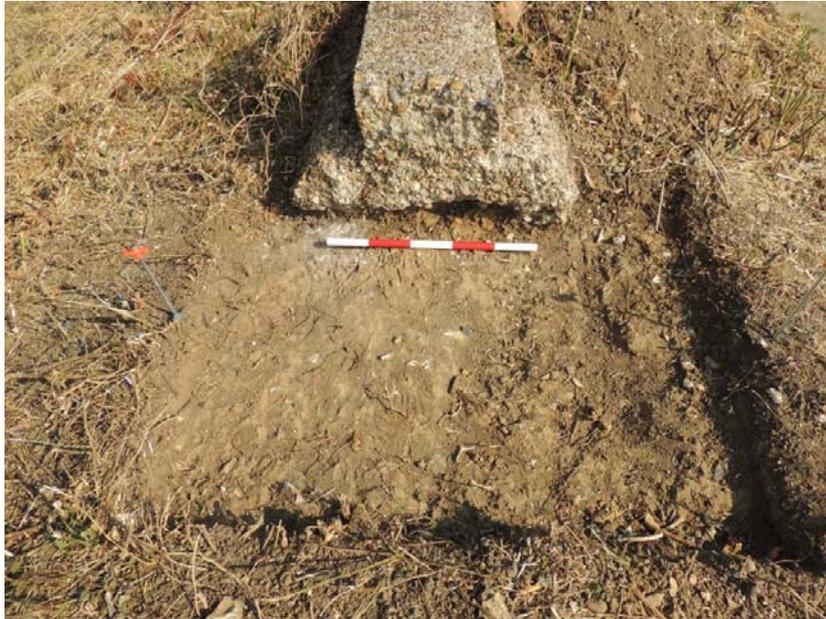
Fig 9 Trench 7b looking north

4.2.4 Trench 7b was a small exposure of the end of the concrete spine [114]. It measured

1m by 0.9m and was dug to expose the base of the spine at 167.4m OD. It demonstrated that originally the concrete spine had continued further south (presumably to a solid “gable” end wall) but it had been deliberately broken through at some point in the past, to make a sloping end to the blast pen wall. The spine apex was at 167.81m OD, was 300mm wide and dropped vertically to 167.6m (west) and 167.66m OD (east), from where it splayed out a further 200mm on either side sloping to 167.49m (west) and 167.52m OD (east) where it rounded to a flat (-ish) base at 167.4m OD.

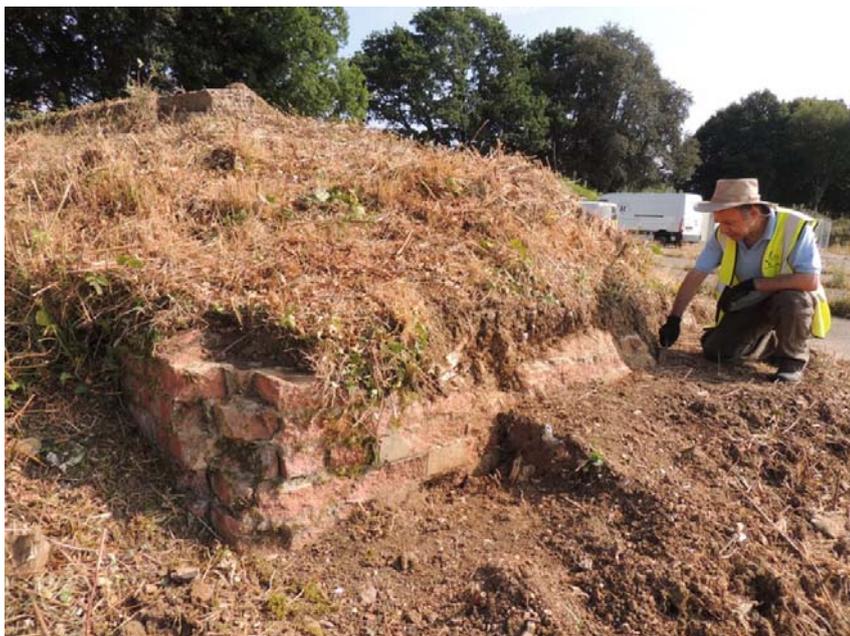
Fig 10 The South and West sides of the original blast wall exposed

4.2.5 **Trench 7c** was a slot dug on the south face, or end, of the west arm of the fighter (blast-) pen, 0.85m wide and 4.5m long, to expose remains of a terminal “gable” wall believed to have been part of the original design. There was indeed a fragment of a greatly truncated wall made of the same Phorpres or Fletton bricks used elsewhere on the aerodrome.

4.2.6 The terminal or gable wall had been reduced to 166.32m OD, slightly below the

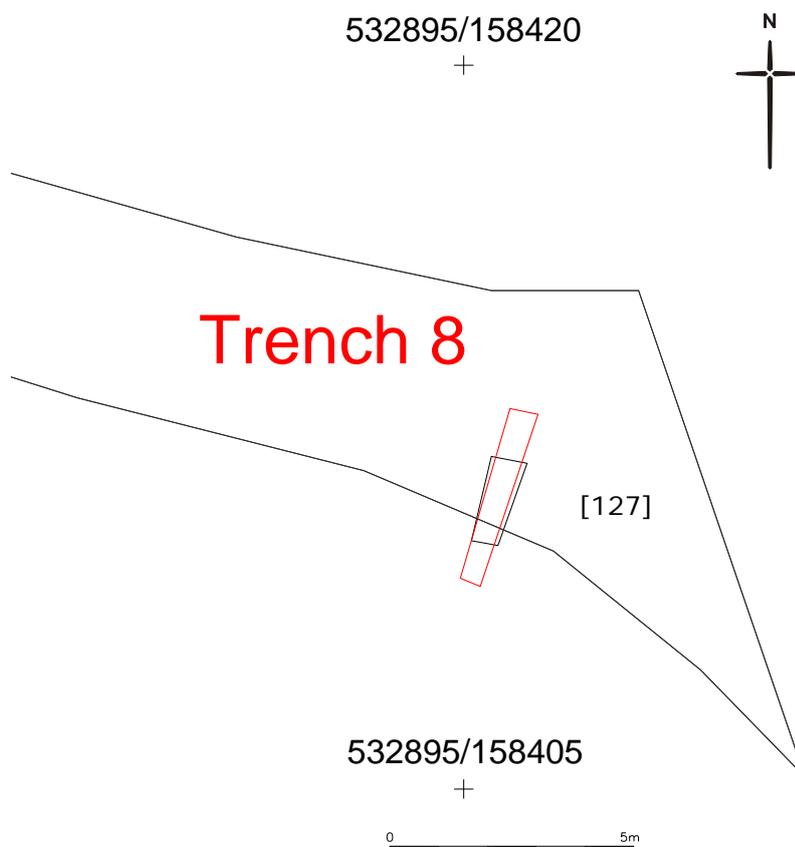
Fig 11 Trench 8 plan

- 4.3.1 Trench 8 lay south of the west arm of the fighter pen. It was located to investigate whether paths that once surrounded the pen on east and west sides survived, and if so, in what condition. It measured 3.5m x 0.38m and was 0.5m deep.

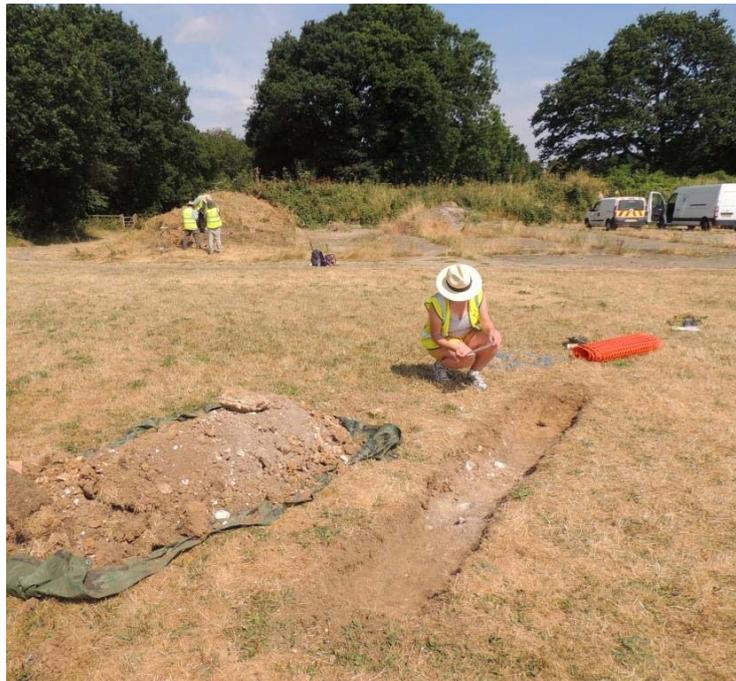
Fig 12 Trench 8 (foreground)

- 4.3.2 In the central area of the trench was an area of hardcore/rubble including concrete and mortar fragments to 300mm diameter [127] at 165.77m OD (0.38m below ground level). This is thought to be the bedding layer for a path, though it wasn't as wide as the path recorded in aerial photographs. This area of rubble was cut into archaeologically sterile clay with flints, presumed to be the natural subsoil. However, it was excavated after an extended period of relative drought and the clay with flints proved too hard to dig into with hand tools, so it proved impossible to dig a sondage to prove it was not a dump of reworked deposits.

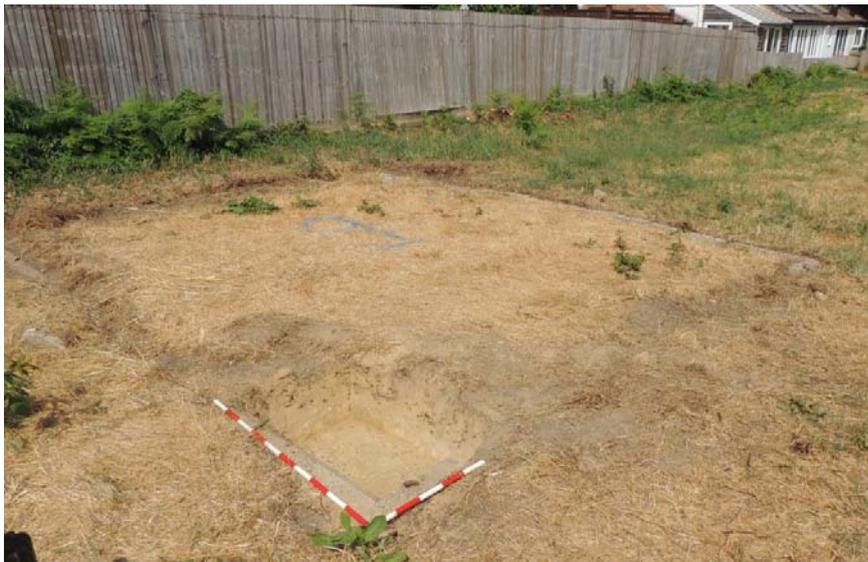
Fig 13 Trench 9 concrete structure [118][120]

- 4.4.1 This structure [118][120][125] lay to the south of that identified in the WSI (which was recorded in Trench 10, below), and in an area that in plans of 1927-8 is referred to as a “machine gun range” (Guy Taylor per. comm.). It was formed of a concrete square base 4.9m x 4.1m at 165.99m OD. Around the outside of this was a 250mm (10 inches?) raised concrete edge 0.1488m (6inches) wide. On the west side there was a break 2.993m wide, where there was no raised ridge. It was filled with sand [119] and a small area only was exposed to the base. The ridge was chamfered internally and had a reinforcing iron projecting from it, which may have connected to precast concrete panels to form an enclosed box, or have anchored something flimsy, like camouflage netting.

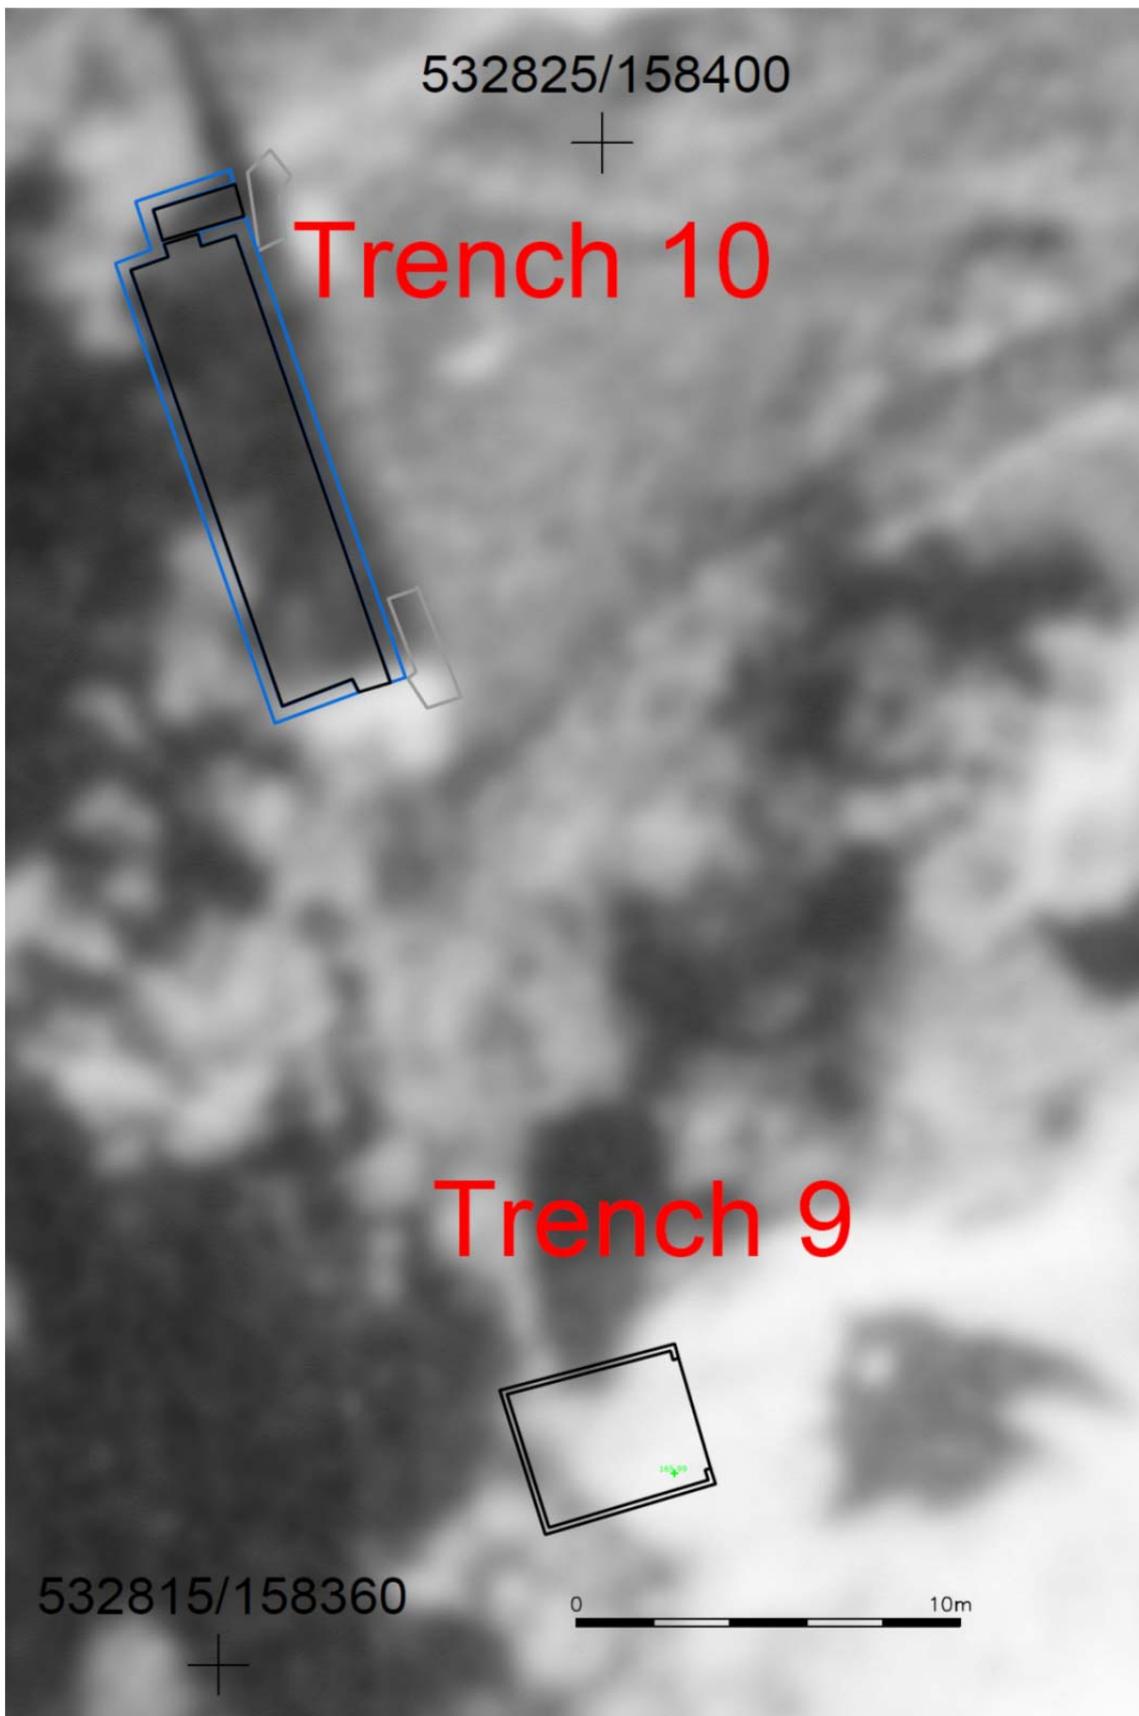
Fig 14 Trenches 9 and 10 with 1941 aerial photo

- 4.4.1 The structure was compared with aerial photos and there is a shadow of a square object to the north of Trench 9, with apparently the right dimensions. However, the photograph and survey are correctly aligned with other features, and yet these two

don't match. It is possible that the excavated remains were those of a later structure of the same size and shape, slightly offset.

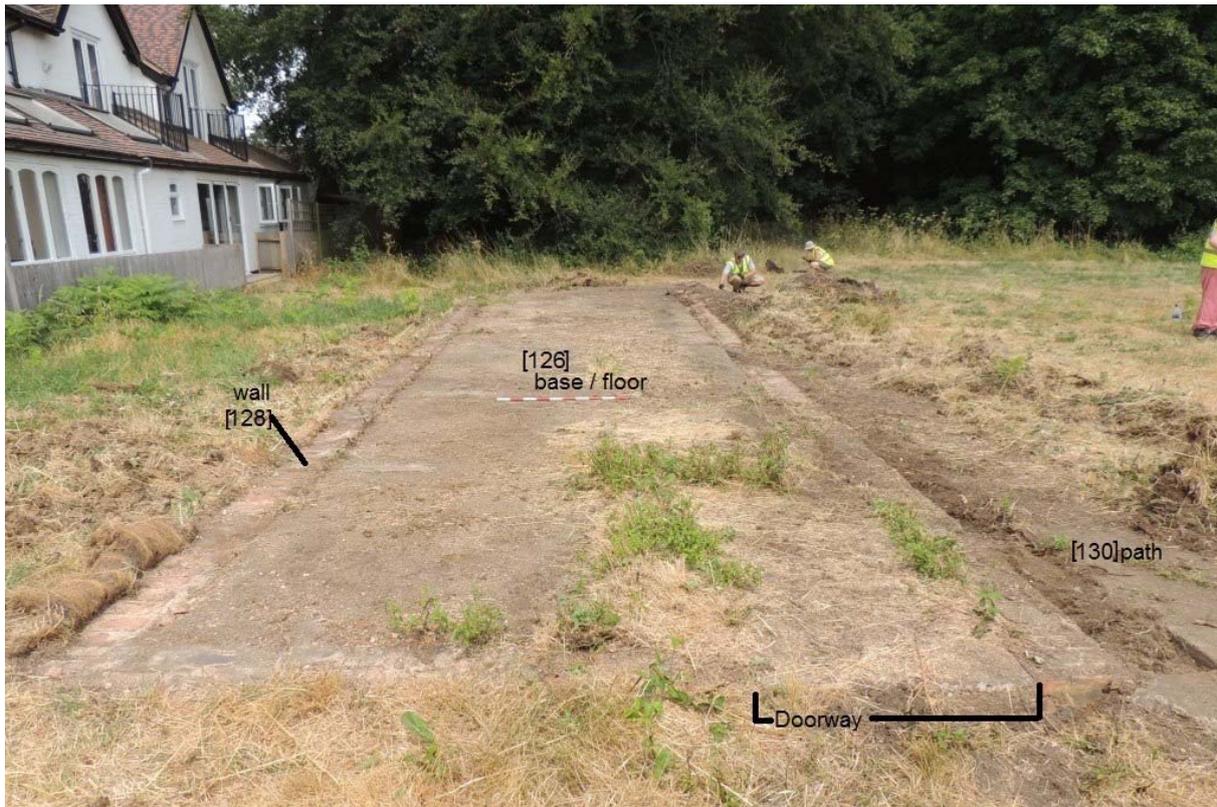
Fig 16 Trench 10 hut, looking north

- 4.5.2 After it was cleared of vegetation, there emerged a hut base, with brick surround, external path and a concrete entrance area. The hut base [126] was formed a rectangle of concrete at 165.694m OD, 12.11m long and 2.88m wide (39ft 9inches x 9ft 6inches?) with two projections, considered likely to be doorways, 0.9m wide and 0.35m – 0.4m wide. The northern doorway was centrally located whilst the southern doorway was on the east end of the southern face. These doorways crossed the base of a brick wall [128], formed of Phorpres bricks laid with a stretcher and header width (alternate courses of which would give English bond). That to the north led to a possible porch, the concrete base of which [129] measured 0.83m x 2.23m at 165.75m OD which may well imply that the external door faced into the airfield at a right-angle to the door into the hut. It too was surrounded by brick walls [128]. Around the east side of the hut and joining both doors was a concrete path, two

areas of which were exposed [130]. It was 0.83m wide, and the maximum surviving level was 165.67m OD.

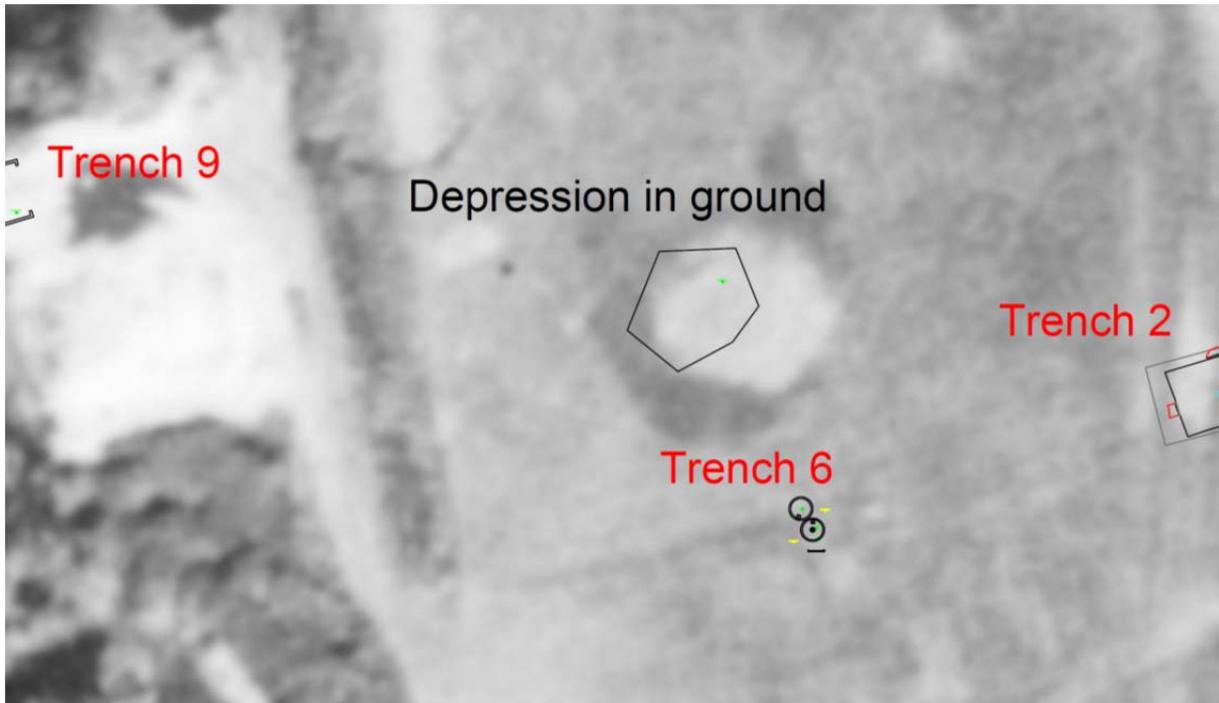
Fig 17 depression and parch mark in the centre of the study area

- 4.6.1 One such was a shallow depression in the centre of the general area of investigation. It appeared in 2018 as a parch mark as well as a slight dip in the ground surface. It measured 8.6m NE–SW and 7.4m SE–NW, centred on 532869.61east 158359.17north and dropped from 166.54mOD on the outside to 166.40m OD in the centre. A 140mm drop over 4m (approx.) is not generally visible when the grass is lush and growing well. However, comparison with the 1941 Aerial photograph Show a larger light patch in this area (as well as showing there was no “Trench 2 possible flight hut” at this time and that the Trench 6 concrete rings were not visible and possibly had not been dug by that date).
- 4.6.2 If the area to the west of the depression was a machine gun range in the 1920s

(Guy Taylor pers. comm.), then it is possible that this depression is a wear mark caused by the repeated anchoring of aircraft to test their machine guns here. Equally, it may have been a gun pit for a larger calibre machine gun than those used in the subsequent concrete rings, subsequently backfilled. Its position near to the machine gun range (BUT not straight in front of it) may not be accidental, though primarily positioned for defence.

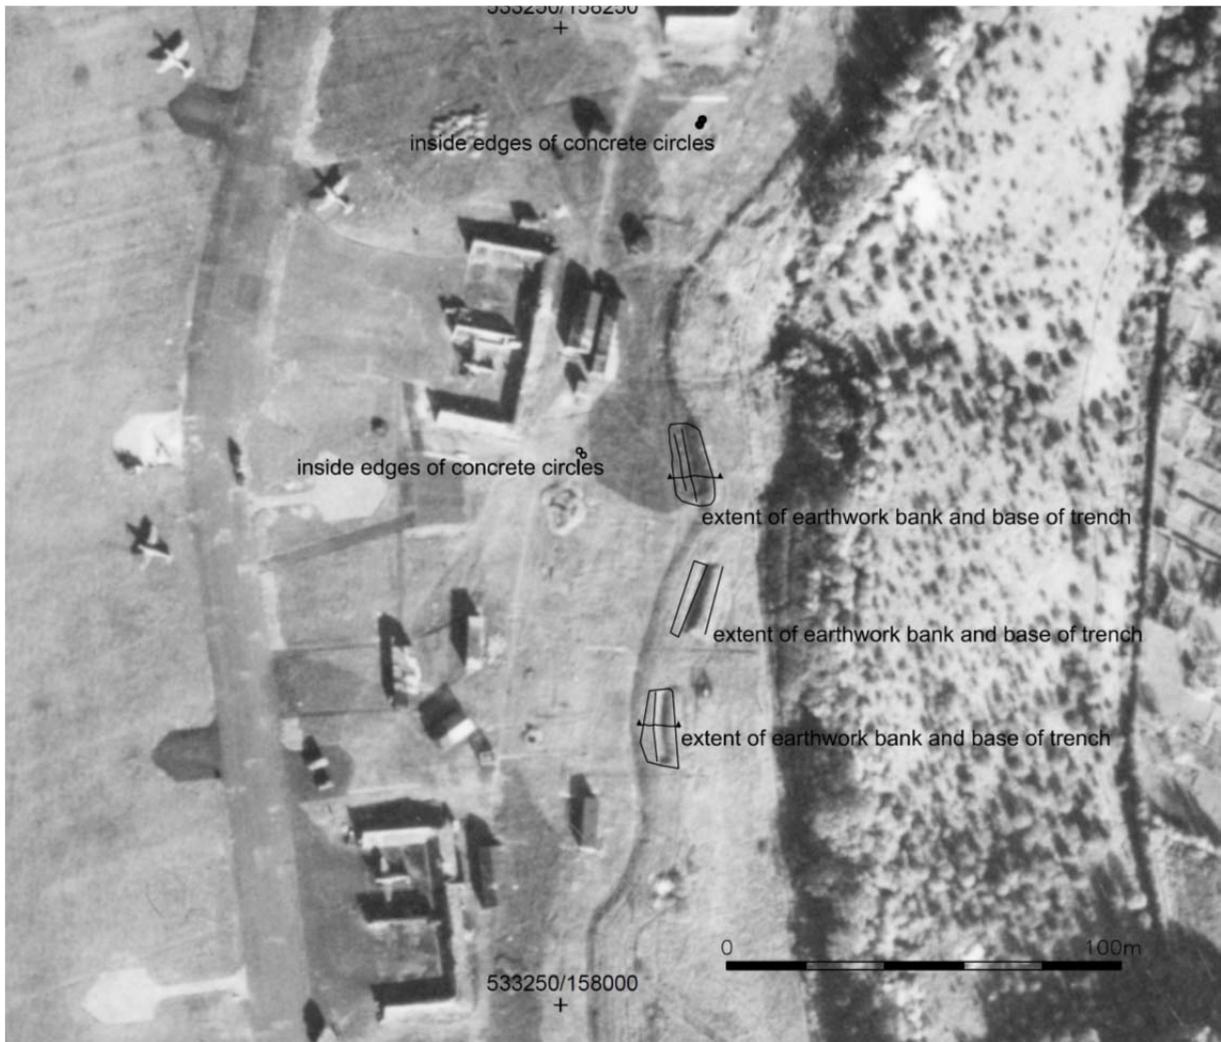
Fig 21 Location of earthworks and concrete circles on 1941 aerial photograph

Profile lines indicated on north and south earthworks

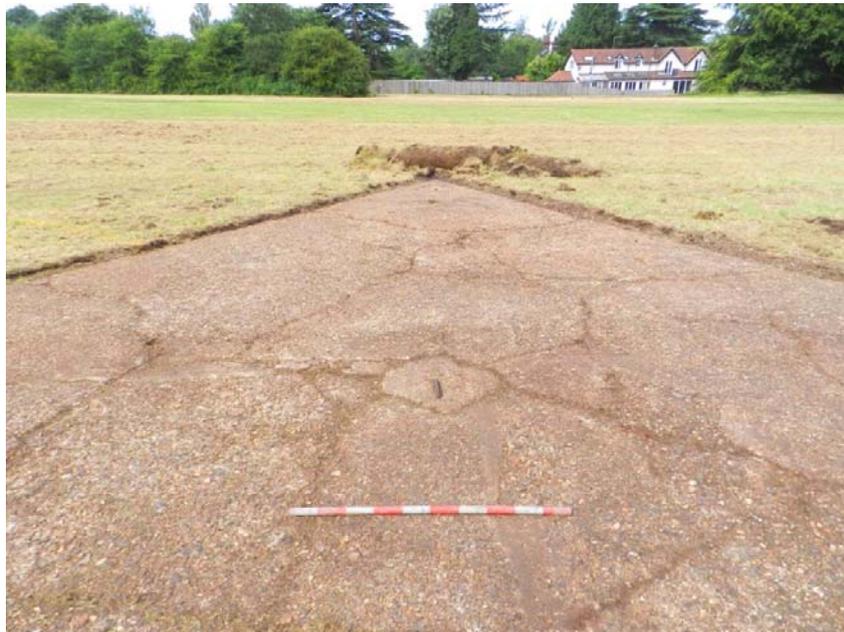
*Fig 23 Trench 1 concrete triangle. Looking west along line of “tie downs”*

- 4.8.1 Trench 1 was located south of the Fighter Pen, north of other 2017 investigations; this trench was intended to investigate a triangular feature that appears on aerial photographs.
- 4.8.2 The concrete triangle [101] was located immediately below a covering of turf. It was an equilateral triangle of 12.9m long sides and was 0.13m thick, made with grey white cement-bonded (predominantly flint) aggregate. It was somewhat domed up to the centre at 166.46m – 166.66m OD. Two iron “anchor points”, formed of an iron bar curved into a loop 200mm across and cast into concrete blocks 450mm, and 500mm square were set laterally along the centre line of the triangle (from east to west).

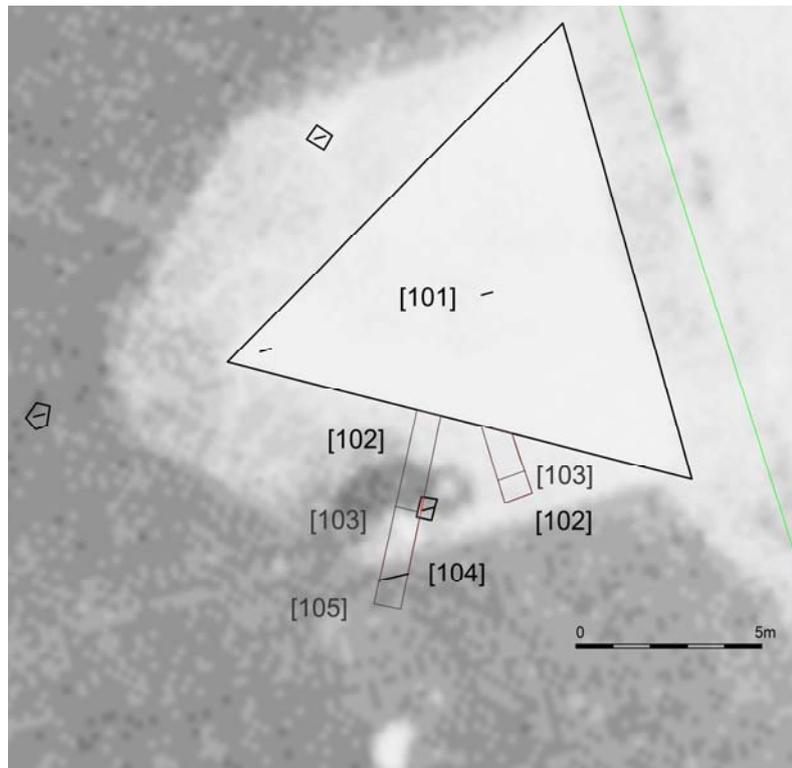
Fig 24 Trench 1 with aerial photograph rectified to concrete triangle

- 4.8.3 Investigating the side and depth of this feature exposed an earlier “version” which comprised of a polygonal shape, similar to others around the perimeter taxiway. This was made of a 100mm thick layer of hardcore and re-used building rubble [103] topped with 130mm – 140mm of tarmac to 166.59m OD. It had been set in a prepared trench [104] dug into brown subsoil [105].
- 4.8.4 A series of three more anchor points, made of curved iron bars set into concrete blocks roughly 0.5m diameter, were set around this tarmac hard standing.
- 4.8.5 Since both polygons of a similar size and shape (on their own) and concrete triangles are present on aerial photographs, it would appear likely that the triangle was a development of, or renewal of, the same structure.

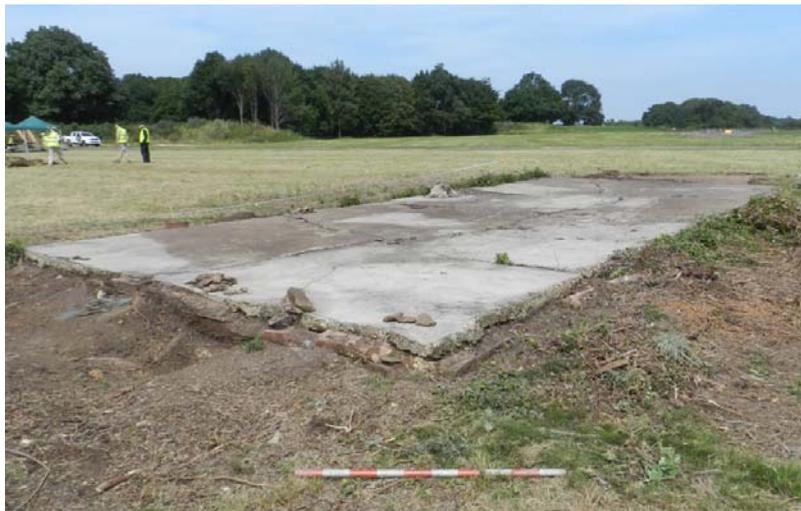
Fig 25 Flight hut foundations, looking North West (lower concrete visible in west sondage)

- 4.9.1 Trench 2 targeted hut foundations south of Trench 1. **Finds recovered in 2017 included thin metal plates, and in 2018 a large horse shoe was found 2m from the west end of the hut.** The remains consisted of an east-west aligned rectangular concrete floor 11.09m x 4.79m, at 167.19m OD. There was a 15mm fine concrete screed [201] laid on a rougher concrete base [202], between 90mm and 130mm thick. This had been cast on brick footings [203] which stepped out 100mm, with one course visible at the south side.

- 4.9.2 A small area excavated on the west side of the concrete floor exposed a second offset of poured-concrete at 166.98m OD, dug into subsoil at (roughly) 166.9m OD. Another on the north side showed two courses of brick laid directly onto earth. The

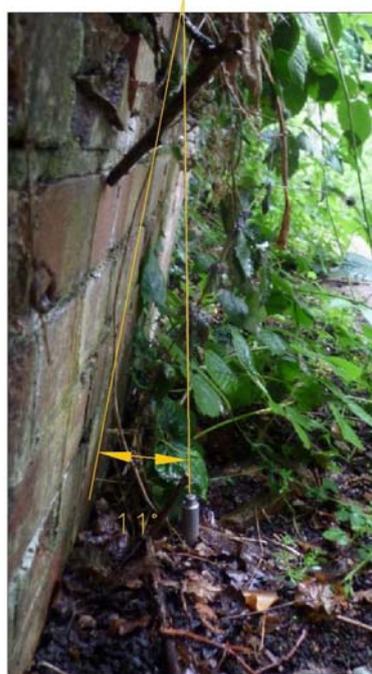
Fig 26 Sloping back (north) wall of fighter pen – subsequently replaced

- 4.13.5 The top of the earth wall was at 168.67m OD, where it covered the tunnel between doorways, but fell to 167.93 west of the tunnel. The outer door floor fell from 166.0m OD at the threshold to 165.3m OD externally. The floor of the doorway was made of concrete grooved diagonally so that water wouldn’t collect in the grooves, but drain down to the side and away. An external revetment wall of Phorpres bricks, built somewhat erratically with some bricks laid on edge, was at 166.23m OD at the top (0.93m high from ground level). Some bricks were in a fragile condition and the whole wall slopes outwards as a result of pressure from the (slumping) earth bank.

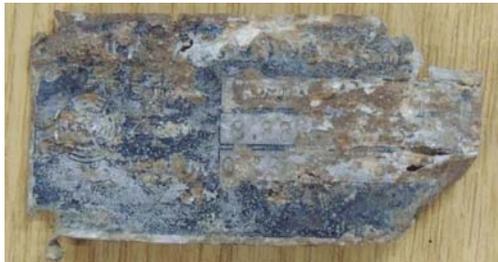
- 4.14.3 Data Plate from German aircraft found in the slumped earth at the end of the west arm of the fighter pen [121]. Information from Vince Gardiner: The top line of text, although in poor condition, reads says '[VOLKSWA]GENWERK Gm[bh]' indicating that it was a product of the Volkswagen company... ..had contracts for repairing aircraft and manufacturing parts for them. The symbol on the left side of the plate is their logo as it appeared during the Nazi era. According to VW's history web page the company had contracts to repair Junkers Ju88 bombers and produce aircraft parts including fuel tanks and wing sections<sup>3</sup>. Although the data plate is very scarred and corroded, it is possible to see that there were three words, each next to a panel where numbers could be stamped. The top one says 'Serie' (serial number), the middle 'Zeichng' referring to the type of aircraft, while the bottom one appears to read 'Herst.Nr' (manufacturers number). The panel next to 'Serie' is almost totally illegible although possibly 'W W' there. The panel beside 'Herst Nr' says '0 36' with a possible '5' towards the right end. The middle panel '8.88' with a possible '5' further to the right and a possible small stamp saying '545' at the far right end'. The '8.88' signifies that it came from a Ju88.

- 4.15.7 The discovery of a German information plate is significant. Several plates have been found at Kenley over the years<sup>6</sup>. It is POSSIBLE that they were collected over a

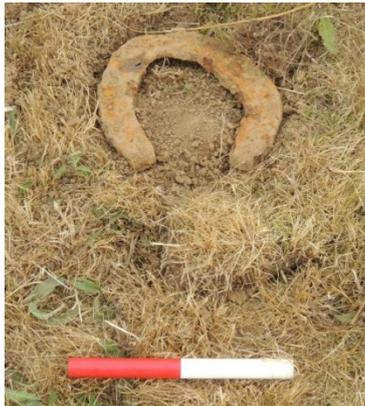
4.14.5 Horse shoe found 2m west of Trench 2 Possible Flight Hut.

- 4.15.6 The horseshoe found nearby could have been cast by a working horse at any point before the site before it became an airfield or possibly later during construction work in World War Two, or even have been used in games of “horseshoes” (quoits). Whilst the trench 10 hut is clearly visible on 1941 aerial photographs, it is not listed on the Site Plan (see above). The Structure west of the fighter pen is both visible on 1941 aerial photographs and is listed as a “Flight Office” also, with a nearby “Drying room” (100).

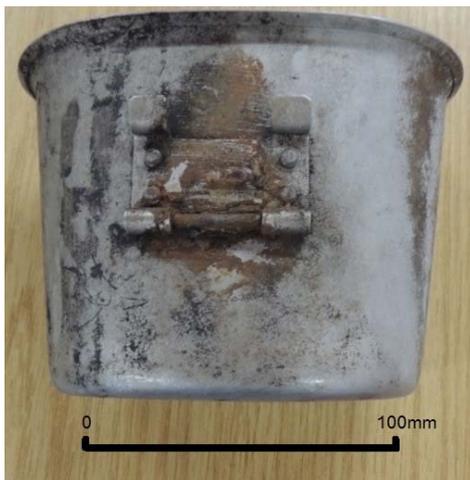
4.14.6 American M1910 Aluminium canteen cup. These were made to fit over the bottom of a canteen, in aluminium treated so as not to be reflective.

- 4.15.8 There are two obvious sources for an American style canteen (water bottle) cup; It could have been deposited during World War One, when American Air Force mechanics were trained at Kenley or it could be from the Second World War when an American fighter squadron was based there. However, it was found in the tarmac of a hard-stand picketing area [102] and would have been of considerable age if it was accidentally incorporated into the rubble that was bound by tarmac (There are cups which the author uses daily which are more than double that age). The USAAF 308th Pursuit Squadron were present in 1942 but that is too late for the context in which the cup was found, unless it was buried in a subsequently dug feature which was not identified during the 2017 works. Both explanations for the cup's presence are plausible. Perhaps a keen student of militaria would be able to distinguish the age of the cup on stylistic grounds, such as the type of fittings or the treatment of the cup edge?

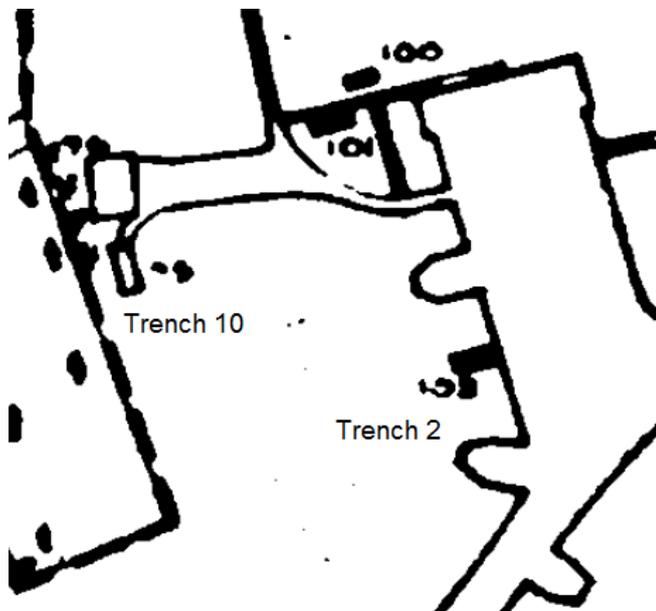
*Fig 27 Extract from Kenley Record Site Plan (AM Drg 2430/46)*

Although tempting to read the Trench 2 hut as 102, next in sequence to 103, no 103 could be identified elsewhere on this plan. Were the Trench 10 hut and the Trench 2 huts original no.s 102 and 103 on the site plan “Schedule of Buildings”?
